DEPARTMENT OF TRANSPORTATION**DIVISION OF ENGINEERING SERVICES**

Quality Assurance and Source Inspection

Contract #: 04-0120F4Cty: SF/ALA Rte: 80 PM: 13.2/13.9File #: 69.28**WELDING INSPECTION REPORT****Resident Engineer:**Siegenthaler, Peter**Address:** 333 Burma Road**City:** Oakland, CA 94607**Report No:** WIR-022859**Date Inspected:** 20-Apr-2011**Project Name:** SAS Superstructure**OSM Arrival Time:** 700**Prime Contractor:** American Bridge/Fluor Enterprises, a JV**OSM Departure Time:** 1900**Contractor:** Zhenhua Port Machinery Company, Ltd (ZPMC), Changxing Island **Location:** Shanghai, China**CWI Name:** Liu Hua Jie.**CWI Present:** Yes No**Inspected CWI report:** Yes No N/A**Rod Oven in Use:** Yes No N/A**Electrode to specification:** Yes No N/A**Weld Procedures Followed:** Yes No N/A**Qualified Welders:** Yes No N/A**Verified Joint Fit-up:** Yes No N/A**Approved Drawings:** Yes No N/A**Approved WPS:** Yes No N/A**Delayed / Cancelled:** Yes No N/A**Bridge No:** 34-0006**Component:** OBG components.**Summary of Items Observed:**

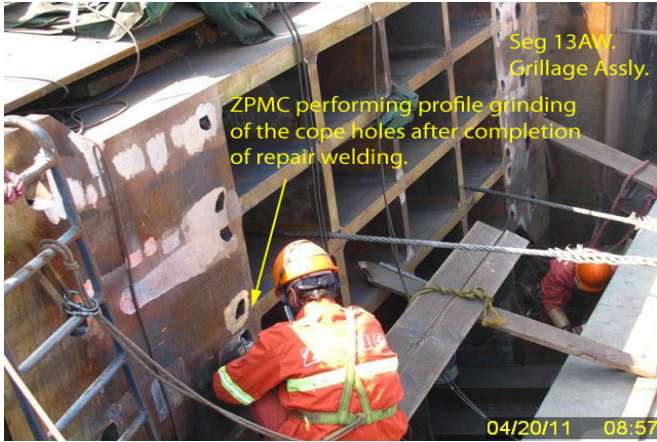
ZPMC personnel performing cope hole profile grinding after completion of repair welding. Repair welding (as per CWR: 2927 Rev-0) of the welds; after MT, was observed to be done. See attached photo for further details.
